Appendix B: Photographs of Delta Levees (Chapter 4)

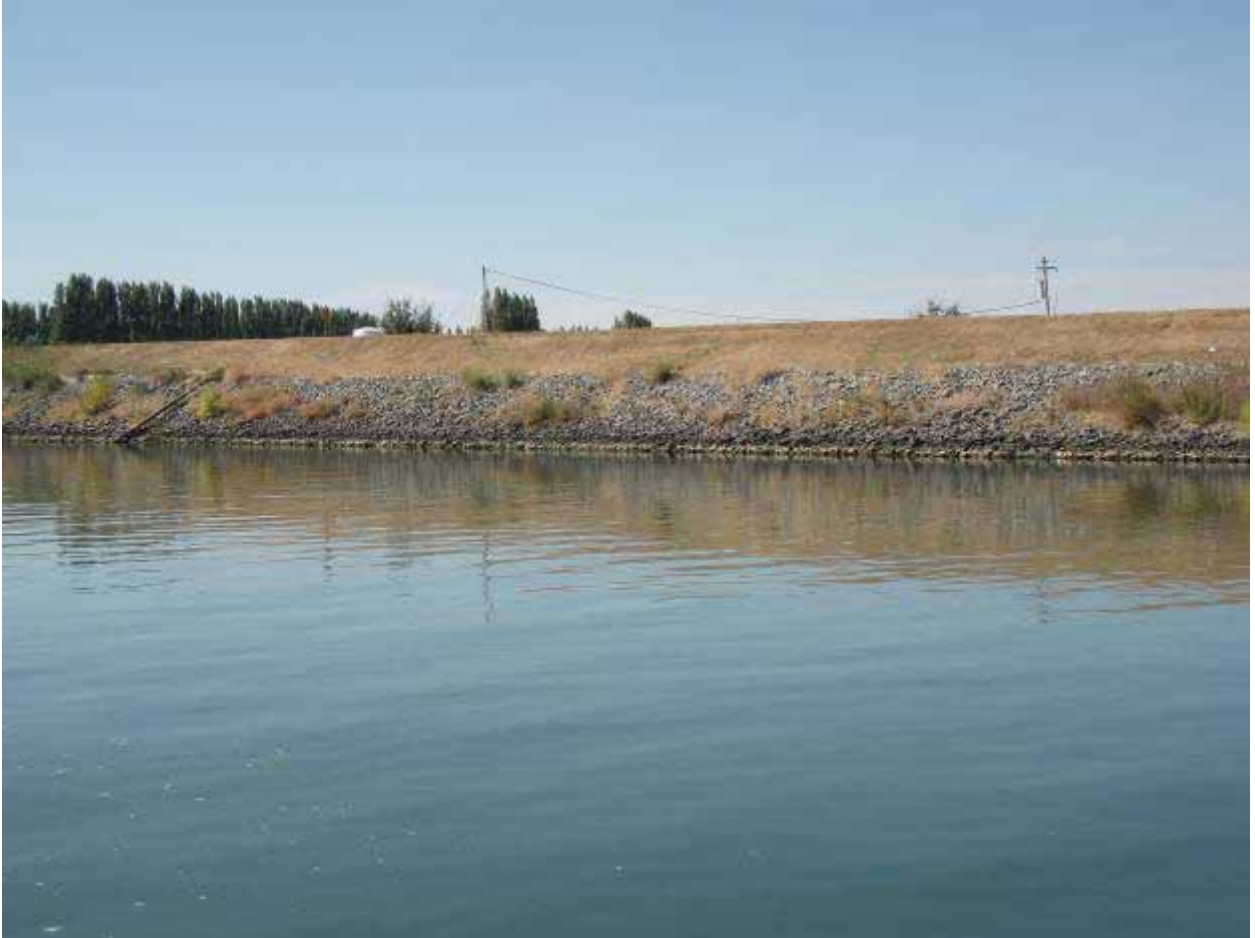
Figure 1 - Sacramento River south of Courtland, showing repair of erosion using rip-rap

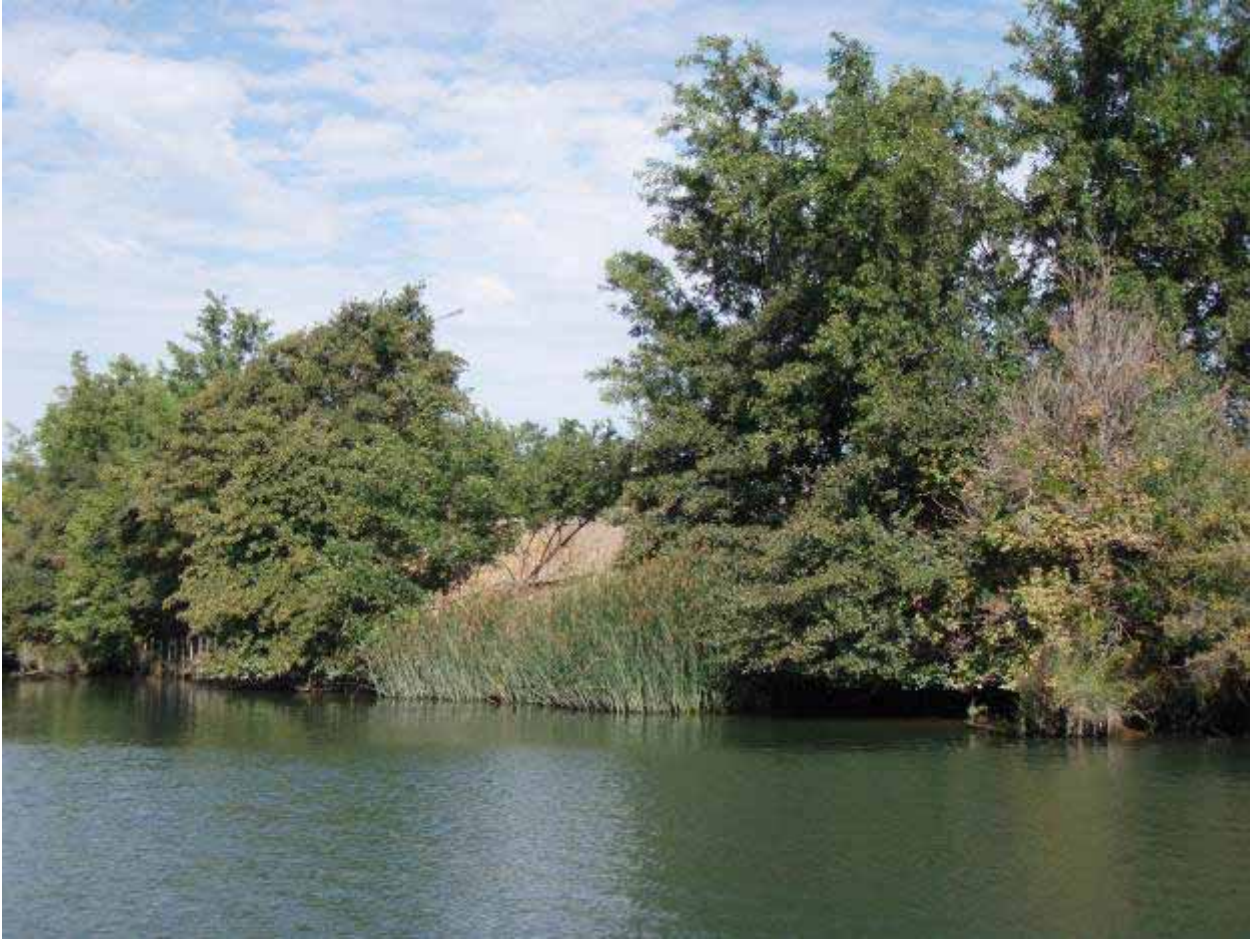
Figure 2 - Merritt Island, showing repair of erosion site using vegetation

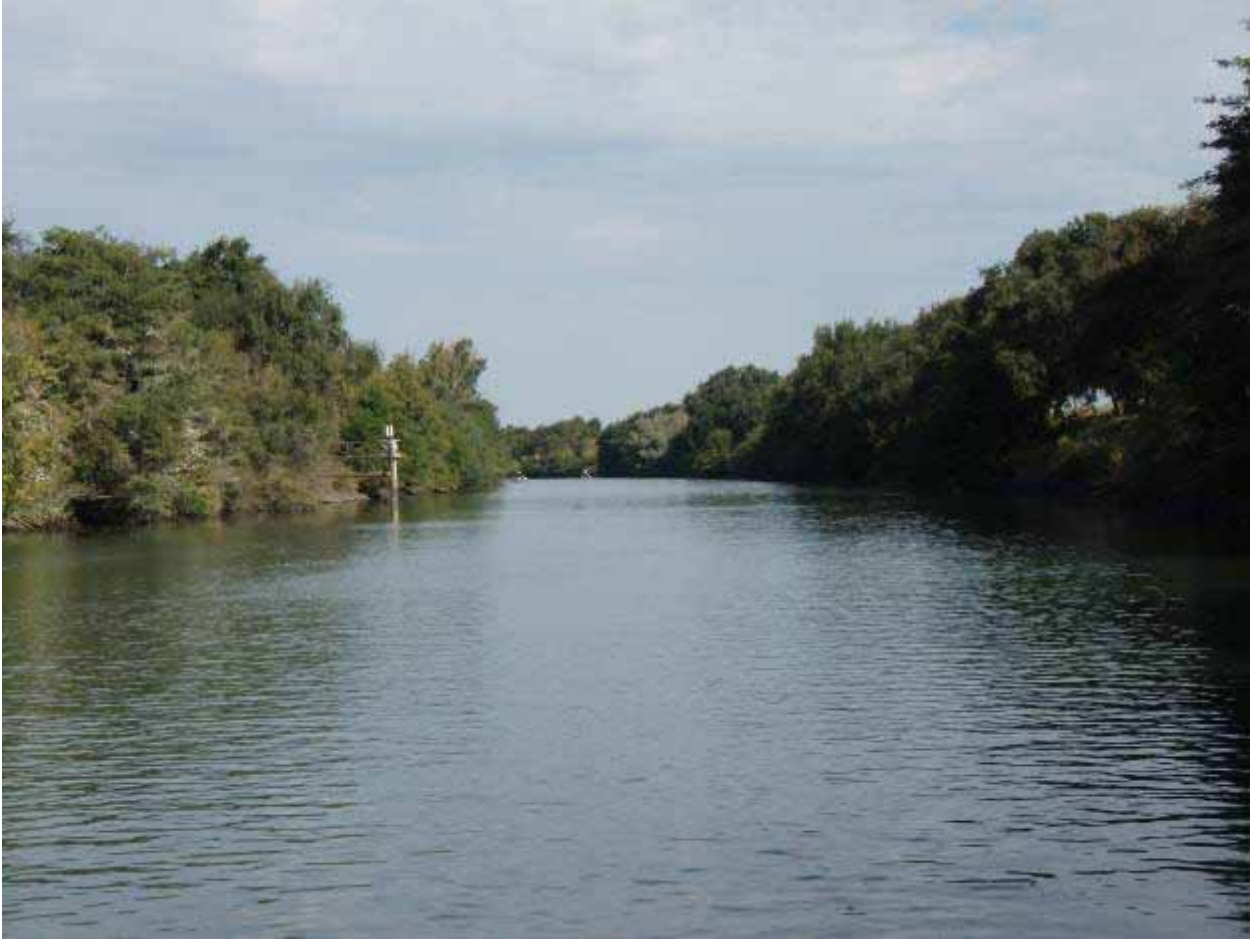
Figure 3 - Sutter Slough, showing natural vegetation on levees

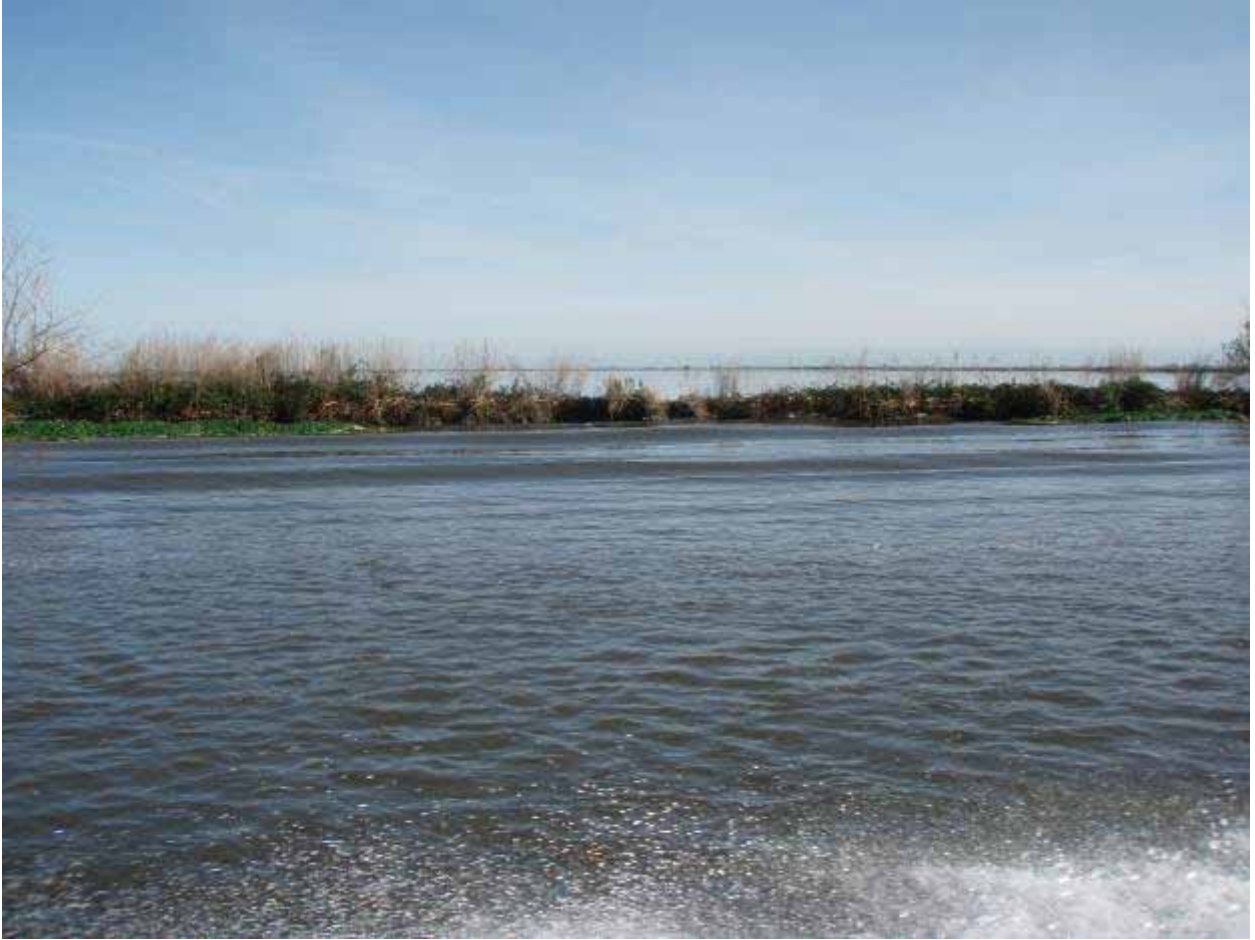
Figure 6 - Mildred Island, showing effect of flooding on levee

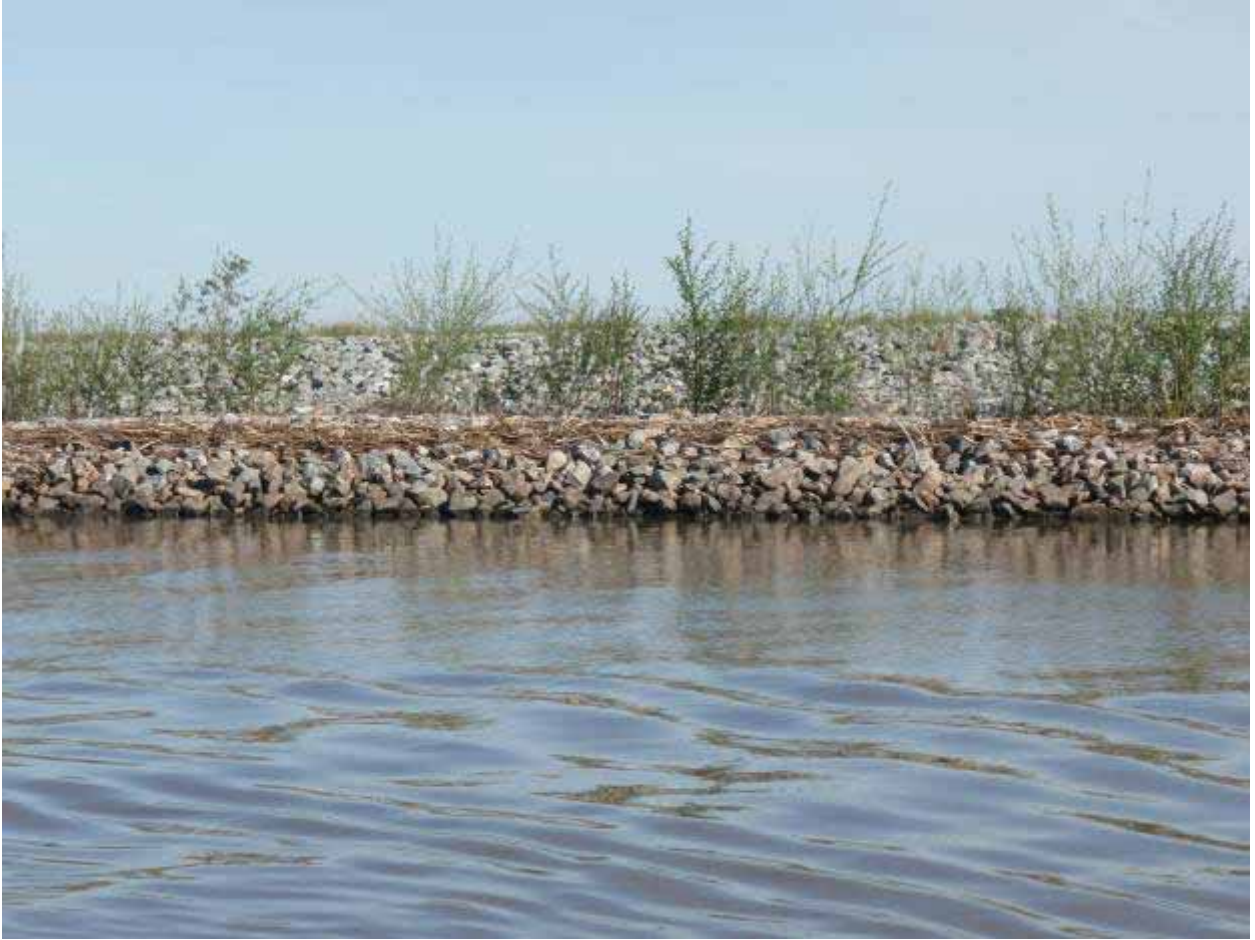
Figure 7 - Upper Jones Tract, showing repair of 2004 breach with eco-bench
